# Manhole Inspection Summary

Manhole # S17GG2014MH

Insp Date: **10/20/06 8:38 AM**

**Location** Address: **5910 SMITH AVE**

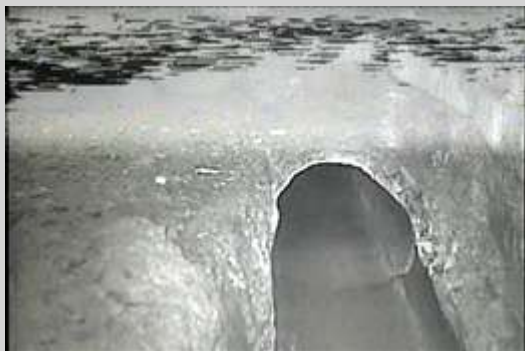
### 8 in. Circular Gravity Sewer Pipe In @ 6 O'Clock

Rod and Bar (Angled)

Pipe Material: **Clay** ☐ Pipe Lined

Infiltration: **None** Pipe Seal Cond: **Unknown**
